BUTLER'S SWAMP, CLAREMONT

By GWYNNETH AUDREY EVANS and NOEL VIVETTE
SHERLOCK, Cottesloe.

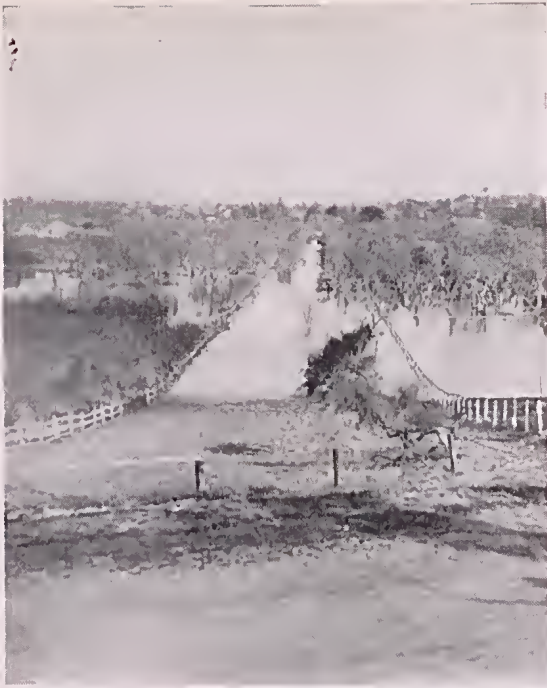
Fig. 4.—Butler's Swamp looking south along Stirling Road from Alfred Road, August 25, 1929.
—Photo W. Pirrett.

The local environment was drastically altered after 1918-1920. The rising of the water level obliterated most of the cultivation, rendered Stirling Road permanently impassable and profoundly changed the character of the vegetation. The paperbark trees, unable to withstand the permanent submergence died off. The photograph in Fig. 4 taken in 1929, showing the bulk of them still alive, is in striking contrast to present-day conditions (Fig. 5).

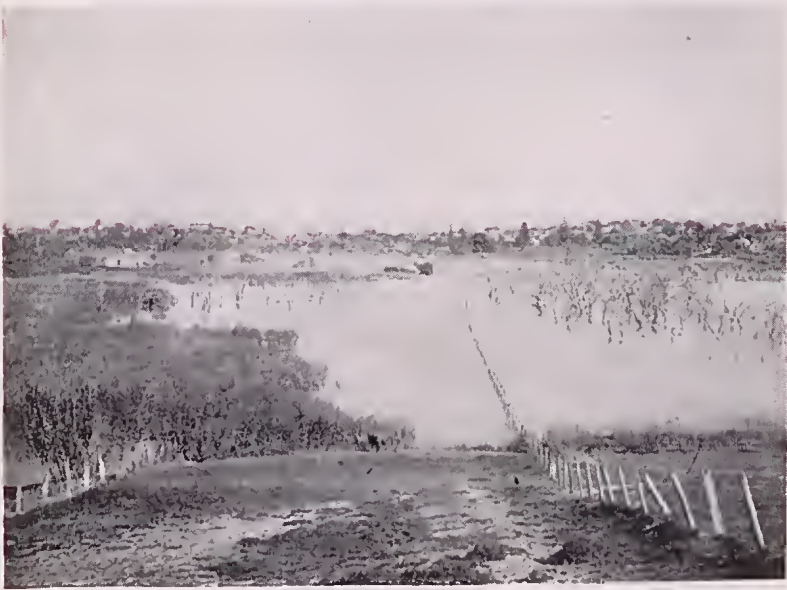
Fig. 5.—Butler's Swamp, the same view on August 16, 1950.
—Photo H. Tarlton Phillipps.
